**OAK RIDGE LEVEL II  
RESERVOIR DAM  
NJ 00014**

**PHASE 1 INSPECTION REPORT  
NATIONAL DAM SAFETY PROGRAM.**

Oak Ridge Reservoir Dam (NJ 00014).  
Passaic River Basin. Pequannock River,  
Morris County, New Jersey.  
Phase I Inspection Report.

OAK RIDGE RESERVOIR DAM (NJ00014)CORPS OF ENGINEERS ASSESSMENT OF GENERAL CONDITIONS

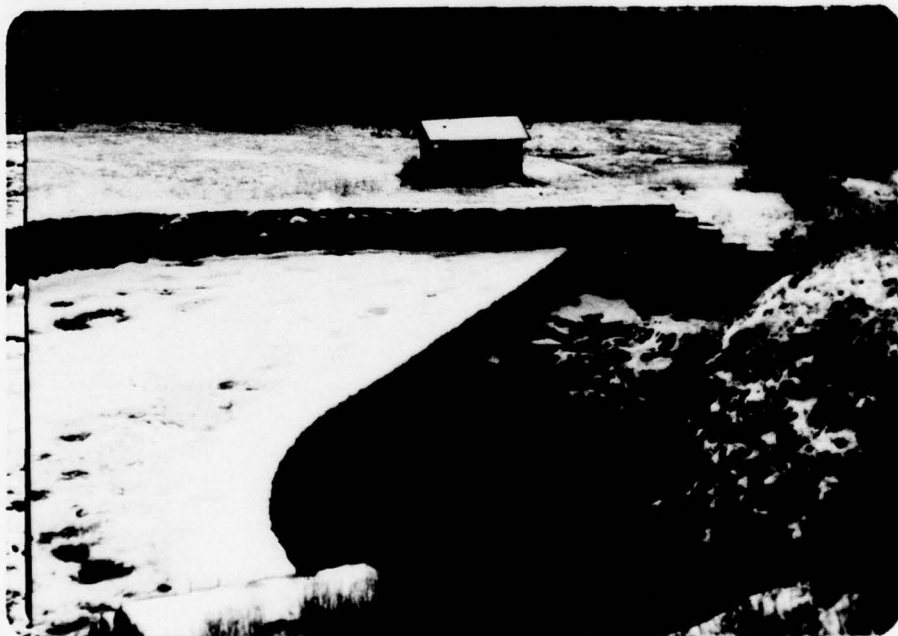
Paved spillway apron leading to rock gorge.

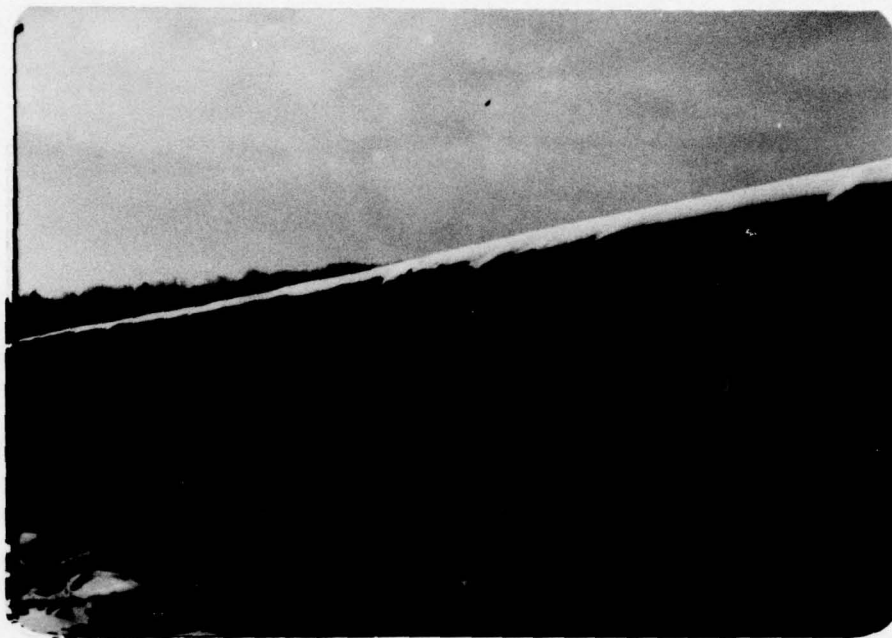
The concrete spillway has cracked and spalled. The spillway wing walls also have small cracks. The paved spillway apron has substantially depressed approximately one foot below the top of the bottom section of the spillway wall. The original construction may have been performed in this manner.

Deterioration of spillway concrete.

3. Debris should be removed from spillway discharge channel. This should be done soon.
4. The open joint and spalled and cracked concrete on the spillway weir should be repaired. This should be done in the near future.

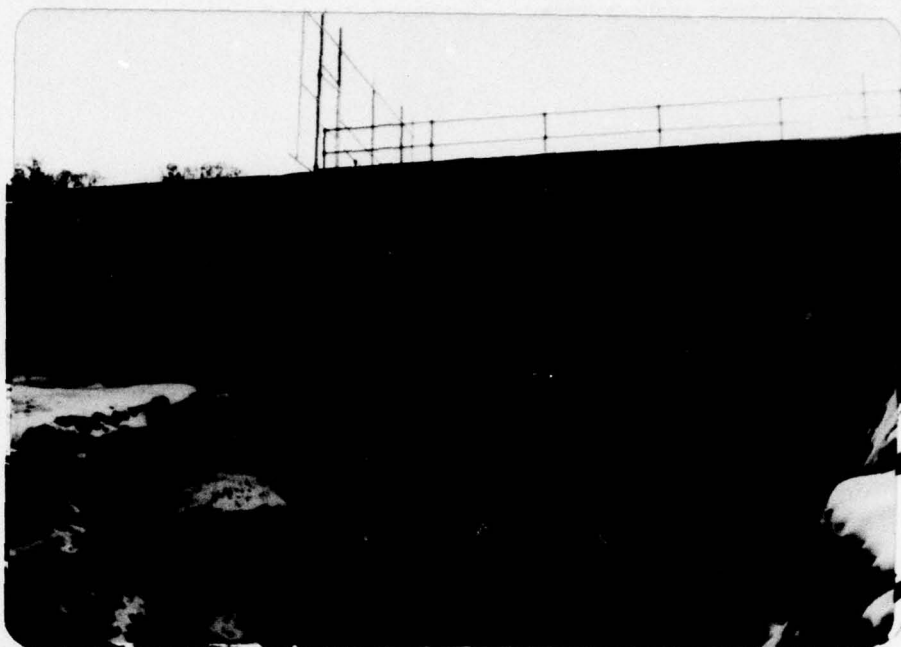
Concrete deterioration at upstream surface of 30 November 1978 outlet chamber.
